ESKIMO III. MAGAZINE SEPARATION TEST

# Eskimo III

## Magazine Separation Test

by  
Frederick H. Weals

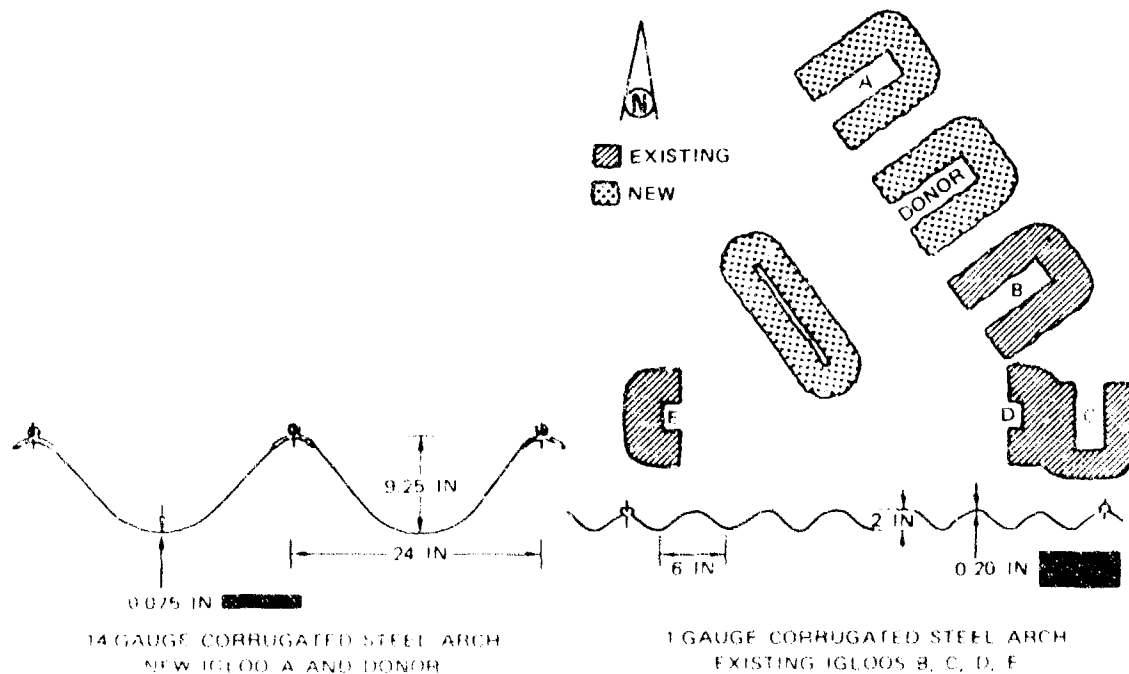
FIGURE 1. Steel Arch Plate Construction for ESKIMO III Igloos.

The donor charge, consisting of 350,000 pounds of Tritonal contained in stacked M117 bombs, was enclosed in an earth-covered magazine, 80 feet long, which was constructed of lightweight, 14-gauge, deeply corrugated steel in place of the standard 1-gauge corrugated metal (Figure 1) but

which was otherwise identical to the standard steel arch igloo. Appendix A presents further construction information. The donor magazine was built parallel to the oval steel arch Igloo B and at the minimum standard spacing from it.

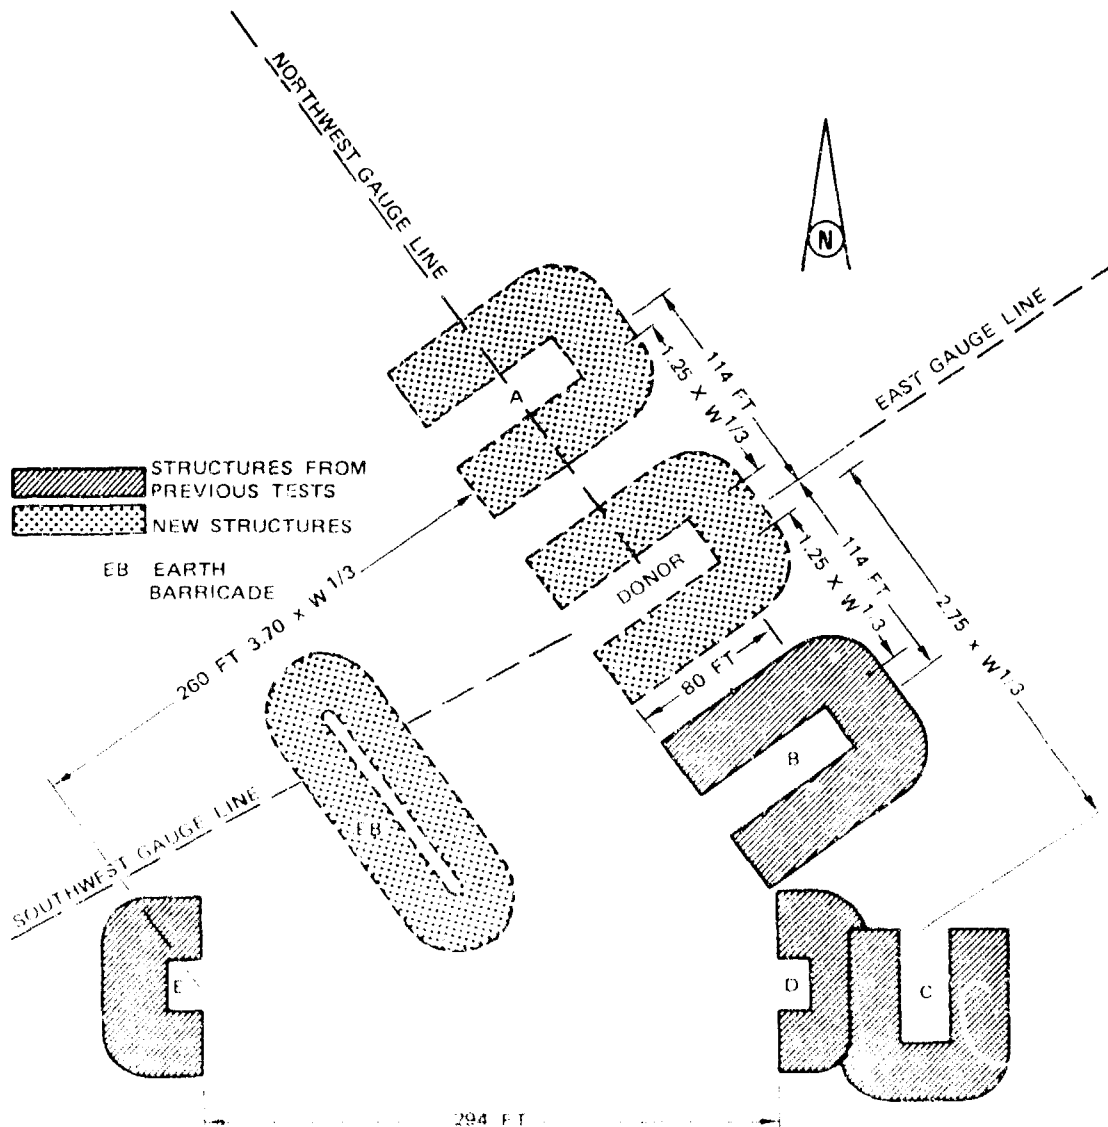
FIGURE 2. Layout of Test Structures for ESKIMO III Magazine Separation Test. A, B, C, D, and E indicate acceptor igloo designations.

Five acceptor magazines were grouped around the donor magazine, as shown in Figure 2. All magazines were earth-covered corrugated steel arches. Igloo A, a 14-gauge, deeply corrugated semicircular arch built to the same specifications as the donor magazine, was located at the minimum

side-to-side spacing now permitted by DDESB standards,  $1.25 \times W^{1/3}$ , from the donor. Igloo B, the existing 80-foot-long noncircular arch adjacent to the donor magazine, was equipped with a modified Stradley-type headwall and single-leaf door.

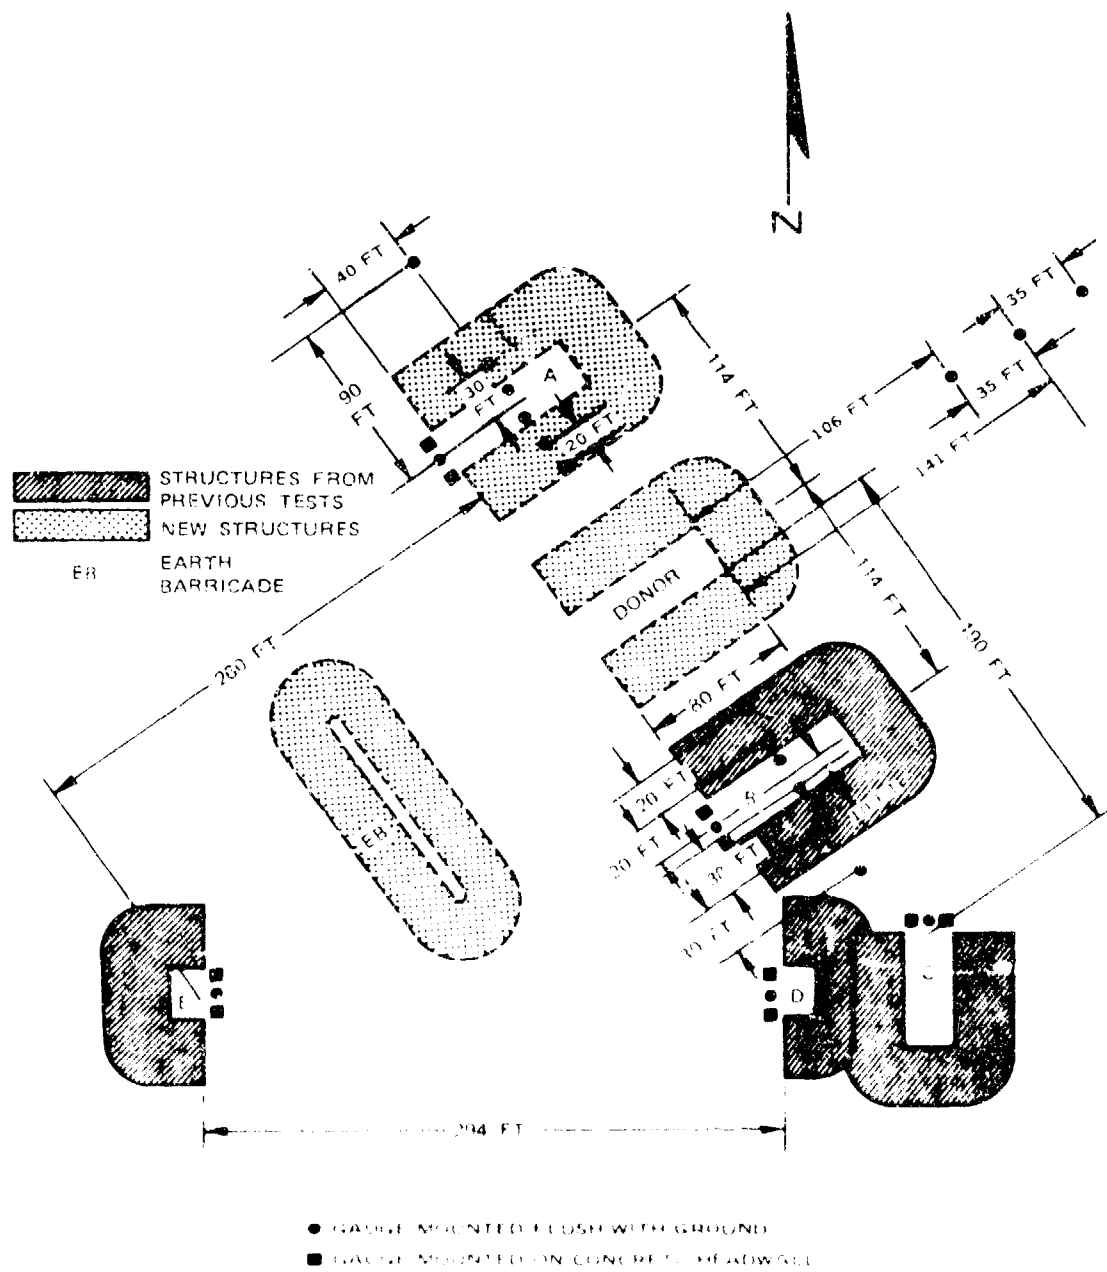
FIGURE 3. Near Field Pressure Gauge Layout

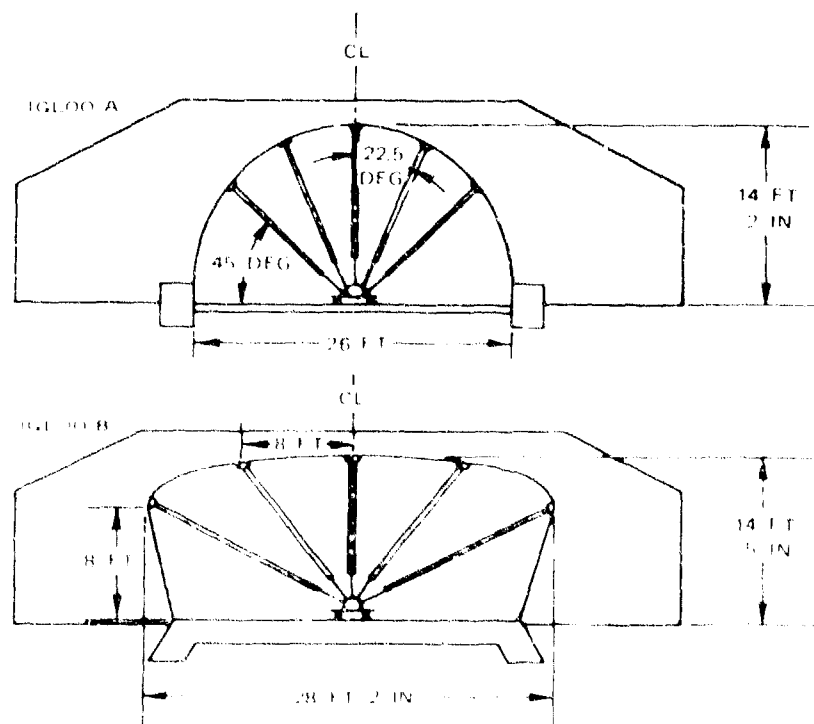
FIGURE 4. Igloo A and B, Dies. Relative Slopes and Locations of Displacement Measuring Apparatus in Each.

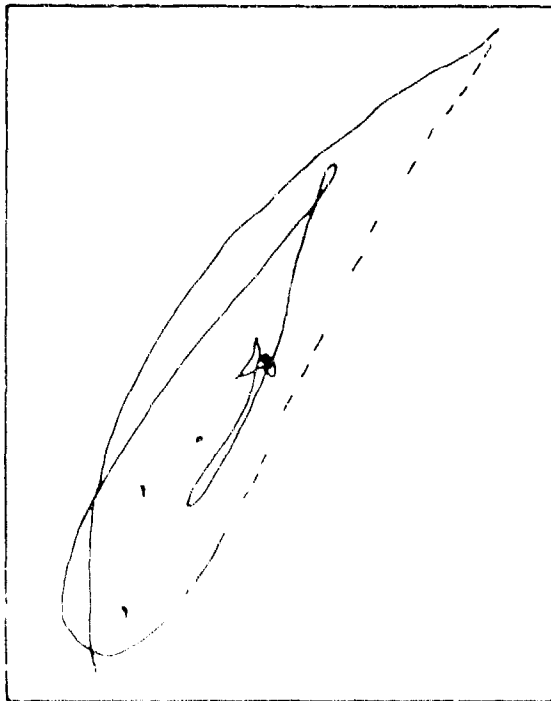
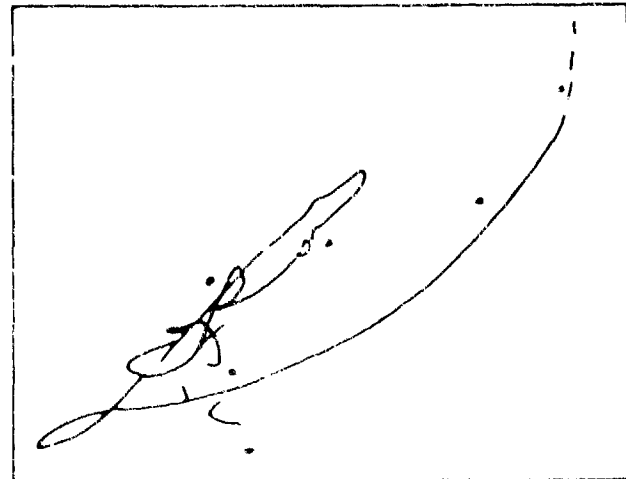
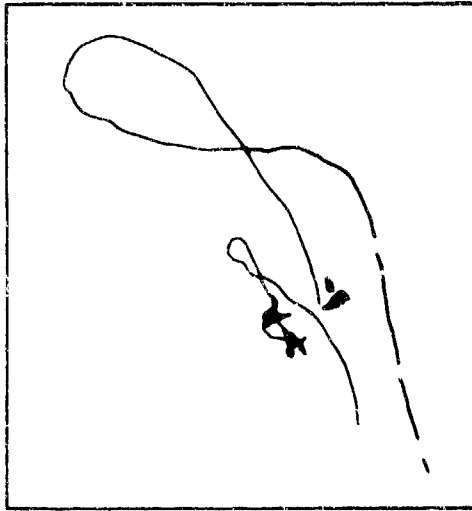
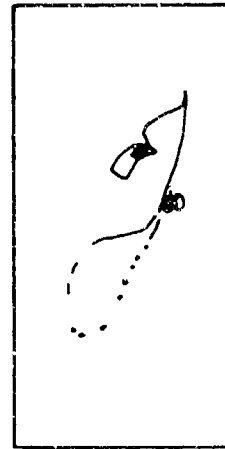
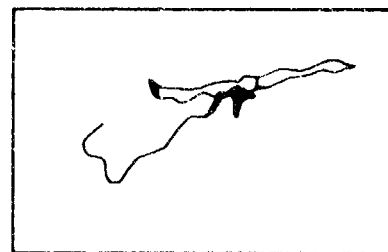
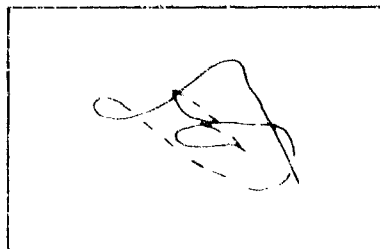
(a) 2,115 feet, Dodge station wagon

(b) 2,115 feet, Rambler

FIGURE 5. Vehicle Motion Signatures, Actual Size

(c) 2,115 feet, Buick station wagon.

(d) 2,115 feet, defauler.

(f) 2,630 feet, VW station wagon.

(g) 2,630 feet, Chevrolet station wagon.

Spring-loaded styli were attached to extensions of some vehicle bodies to provide a signature of vehicle motion on a fixed aluminum sheet rigidly attached to the ground. Figure 5 represents the actual size records from these scratch gauges.

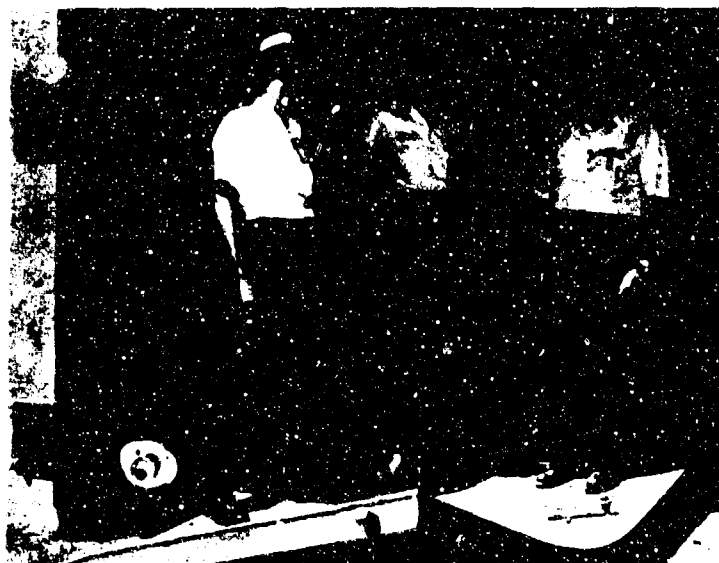
FIGURE 10. Official Visitors to the Test Standing on Right Leaf of Door to Acceptor Igloo A. (Neg. IHL 183160)

viewed by an observer on the outside and facing the magazine door) coming to rest in a near vertical position, lodged between the igloo arch and floor. The right leaf came to rest in the igloo doorway with the exterior face up (Figure 10).

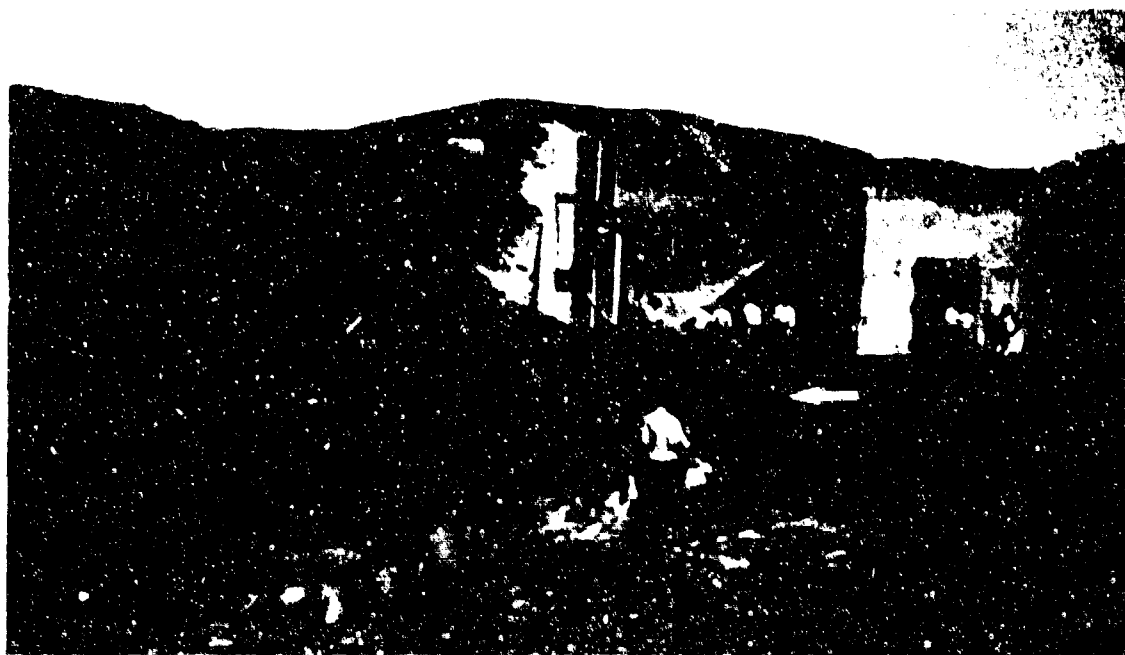
FIGURE 12. Donor Magazine Center With Acceptor Igloos B and D in Background. Arrow indicates position of the single left door from Igloo B. (Neg. EHE 183163)

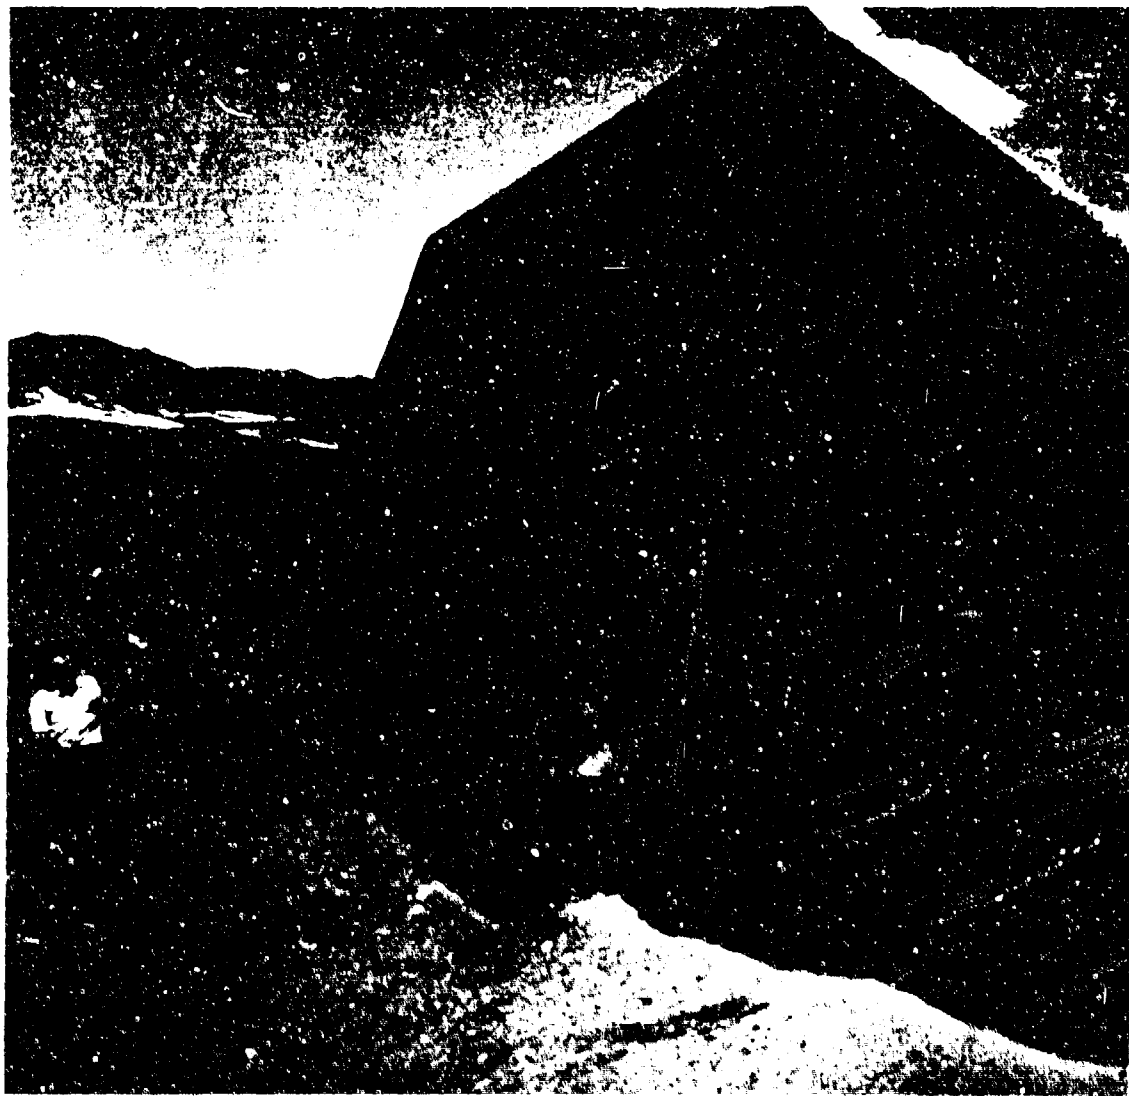
FIGURE 16. A. POST-BLAST DAMAGE TO CONCRETE HEADWALL (1963)

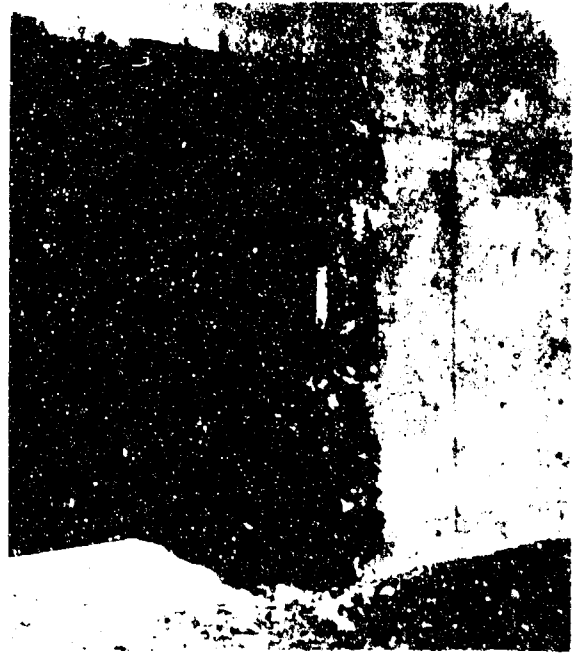
FIGURE 18. Right Side of Doorway of Acceptor Igloo D. (Neg. LHL 183172)

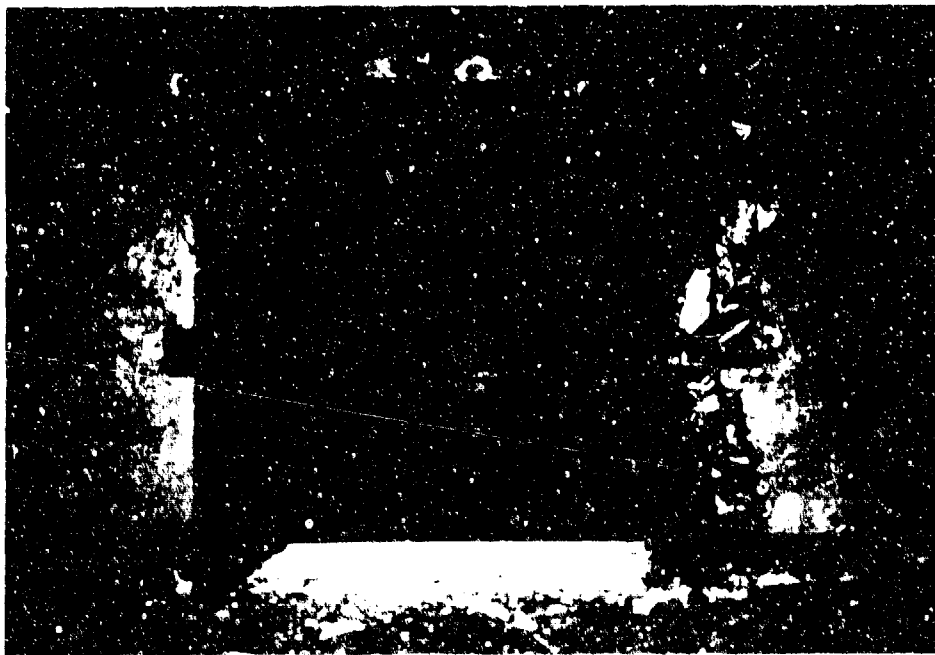
FIGURE 19. Igloo D, Doorway. (Neg. LHL 183173)

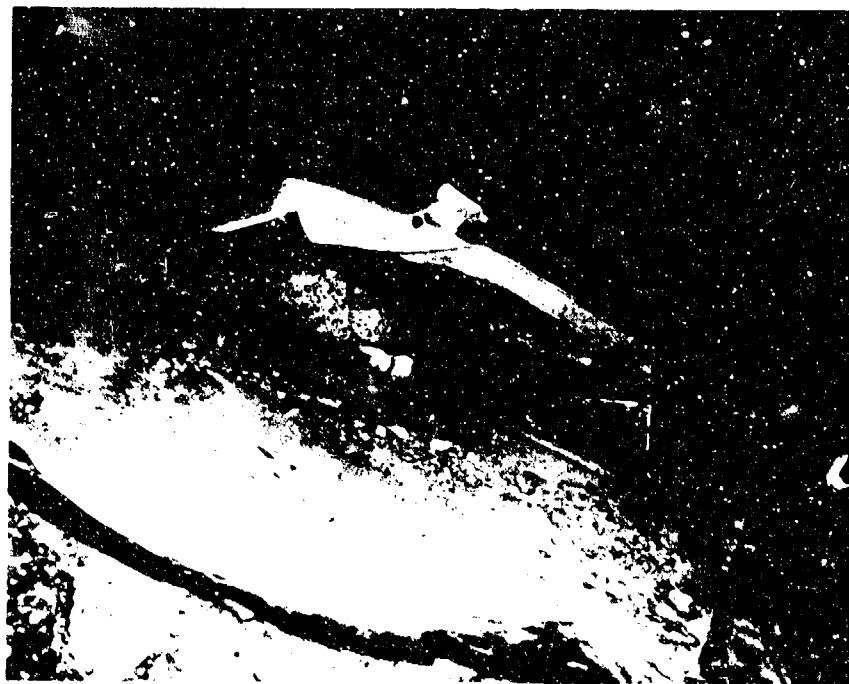
FIGURE 21. Right Side Interior of Igloo E. (Neg. LHI 183176)

The most severe door and headwall damage was experienced by Igloo E. Here the door-leaf damage and deformation indicated that the leaves were thrown inward with significant velocity (Figures 20, 21, and 22) and would have jeopardized any stored explosives. Additionally, the steel channel used for the left doorjamb and the door head were separated from the concrete headwall (Figure 23). The headwall experienced considerable damage, with a maximum inward movement of approximately 1.5 feet where the bottom portion of the left doorjamb separated from the floor (Figure 24).

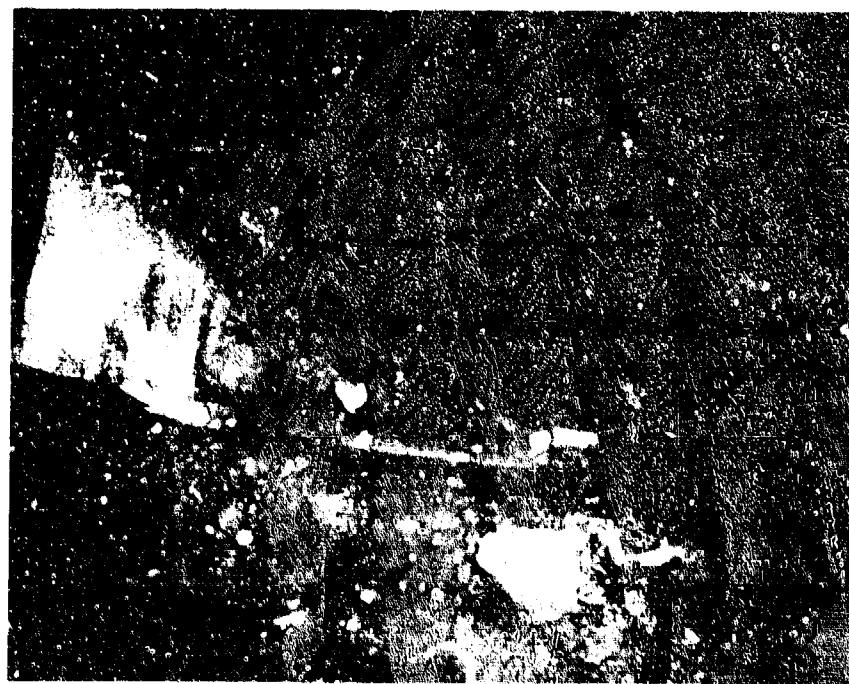
FIGURE 22. Igloo E, Left Side of Igloo E. (Neg. LHI 183177)

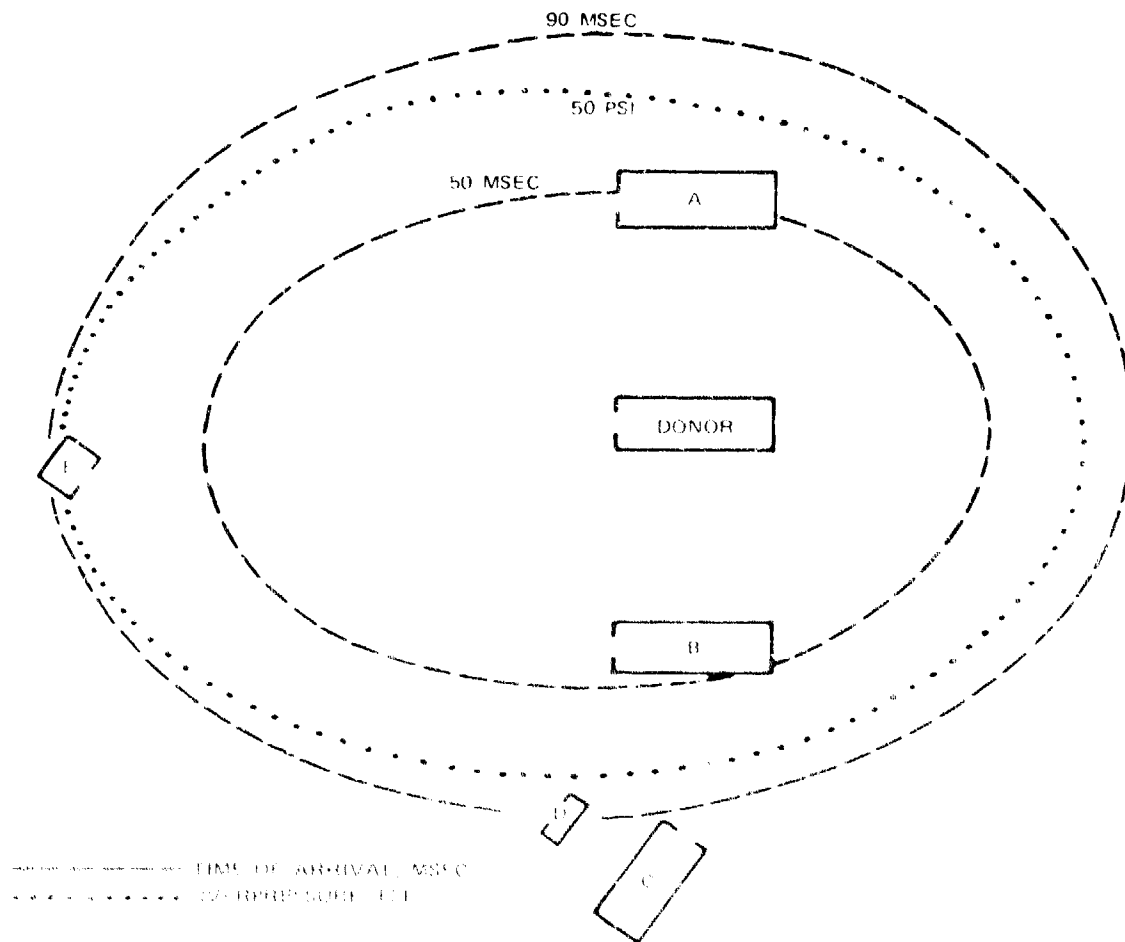
FIGURE 25. Near Field Blast Patterns

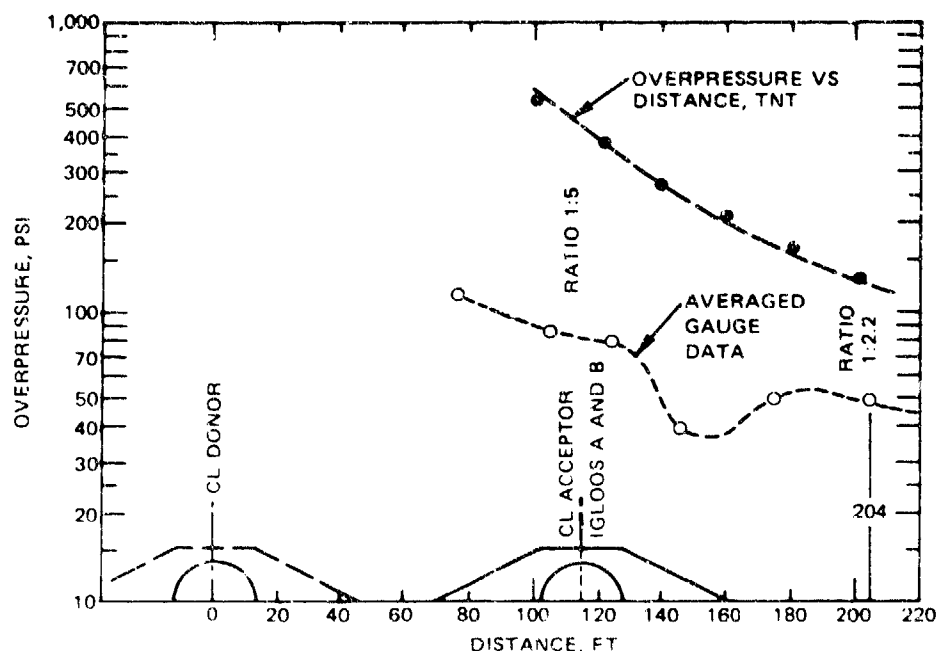
FIGURE 26. Overpressure Versus Distance in the Near Field.

Figure 26 shows graphically the averaged overpressure data acquired in sideward directions from the donor igloo (at right angles to the longitudinal centerline) compared to expected values from an

equivalent weight of TNT. This shows that expected overpressures from the unconfined TNT charge are approximately five times as great as those actually experienced at a distance equal to that from the centerline of the donor structure to the centerline of acceptor igloos A and B. The ratio reduces to 1:2.2 at sideward gauge positions 204 feet from the centerline of the donor igloo. This position approximates the position of a headwall in the minimum face-to-side orientation of  $2.75 \times W^{1/3}$ . At sideward positions 1,320 feet from the donor centerline, the ratio reduces to about 1:1. These same comparisons are shown in a different form in Figure 27 which also compares a standard TNT curve with overpressures fore and aft of the donor igloo in addition to those to the sides. Figure 27 shows that blast overpressures recorded to the rear of the donor igloo remain well below standard values for an unconfined charge<sup>3</sup> at distances out to 1,320 ( $18.7 \times W^{1/3}$ ) feet and that overpressures recorded forward of the donor exceeded standard values at near-field positions ( $\approx 300$  or  $4.25 \times W^{1/3}$  feet) but dropped below standard values for 1,320 and 2,115 ( $30 \times W^{1/3}$ ) feet. Averaged overpressure and impulse data show that at 660 feet from the center of the donor, the blast approximated that from 225,000 pounds of unconfined TNT in a hemispherical configuration. The corresponding value at 1,320 feet is 255,000 pounds of TNT.

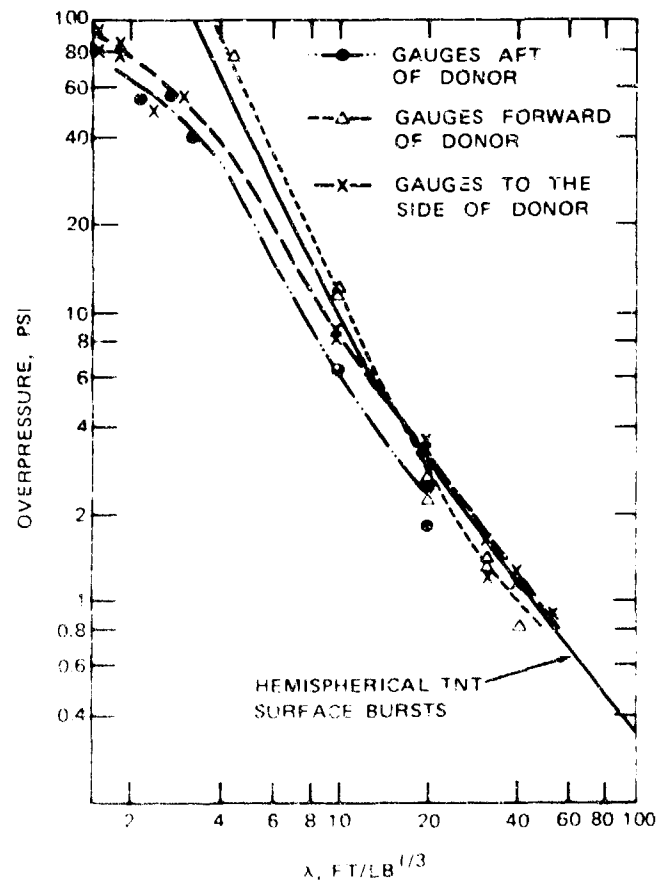
FIGURE 27. Plot of Overpressure Versus Scaled Distance  
(a). Compare ENKIMO III Blast Data With Standard TNT Blast Data. Assumed effective explosive weight,  $W$  298,000 pounds.

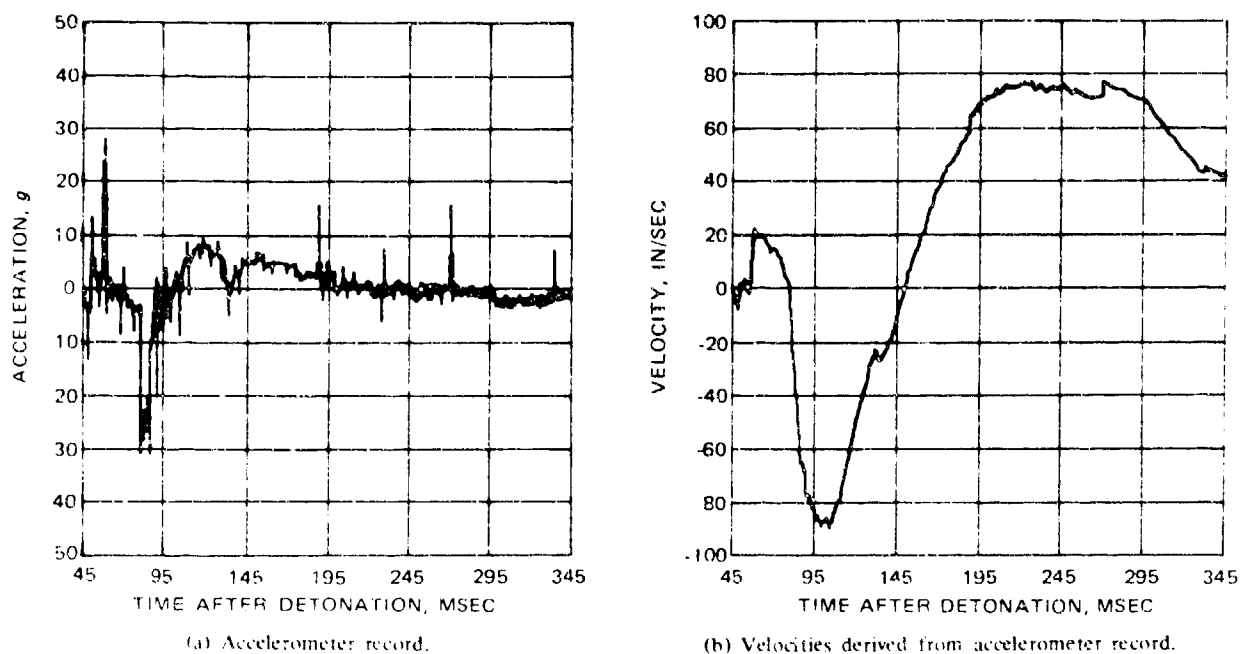
FIGURE 28. Accelerometer Data. These data were obtained from the accelerometer located on the vertical centerline of Igloo A and 20 feet from the door and headwalls.

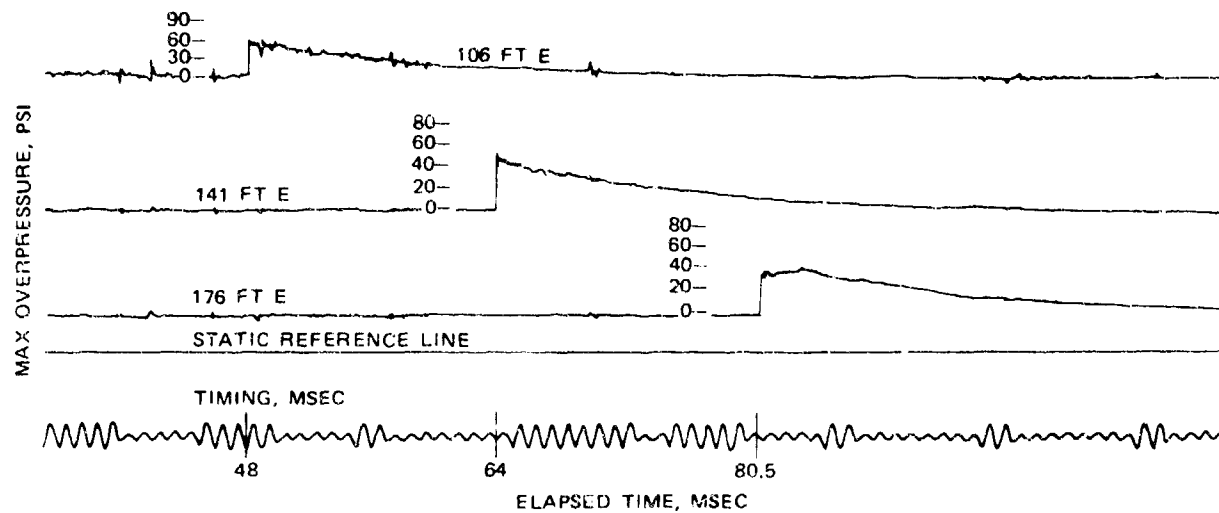
FIGURE 30. Kistler Piezoelectric Blast Gauge Data. Time of blast arrival versus peak overpressure. Gauges located to the rear of the donor igloo.

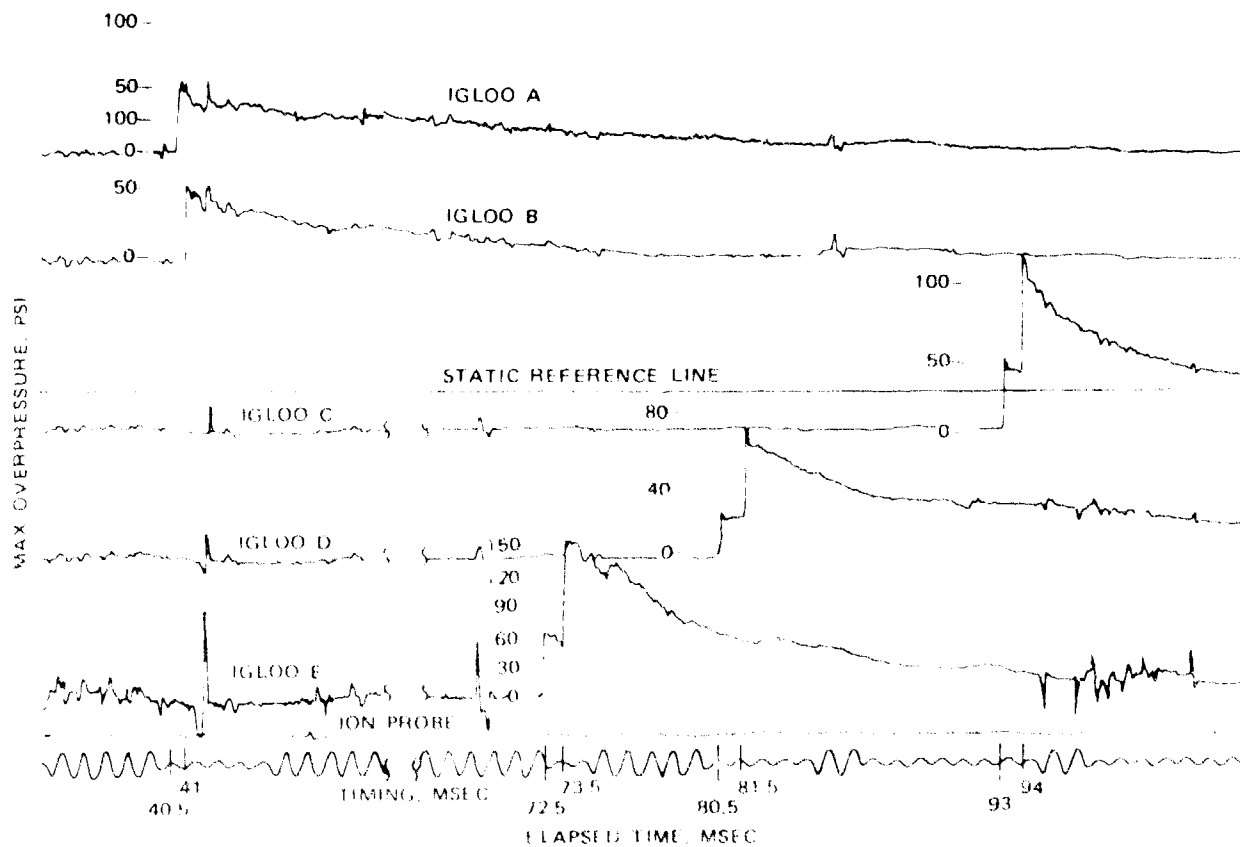
FIGURE 31. Kistler Piezoelectric Blast Gauge Data. Time of blast arrival versus peak overpressure. Gauges located at ground level in front of the igloos. Note that the time scale has been overlapped in order to show all events on the one figure.

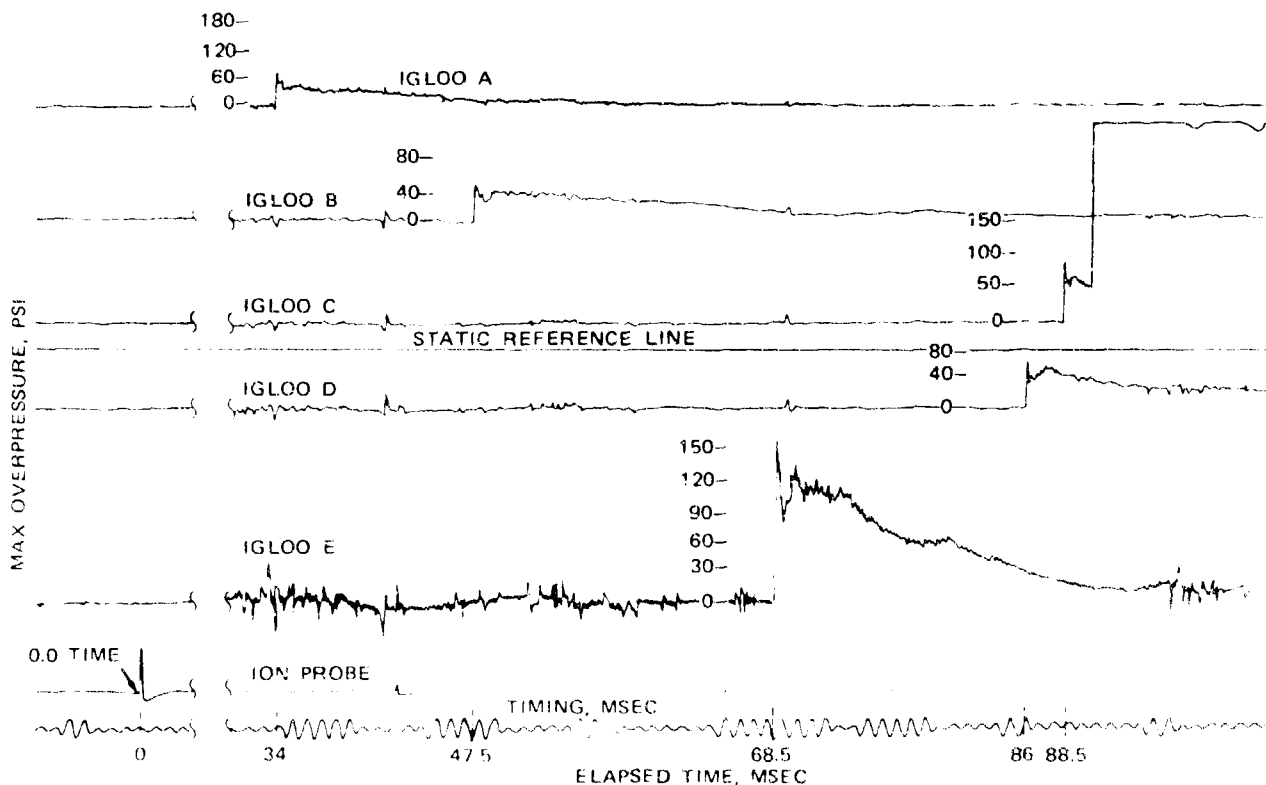
FIGURE 32. Kistler Piezoelectric Blast Gauge Data. Time of blast arrival versus peak overpressure. Gauges located in the right headwall of each igloo.

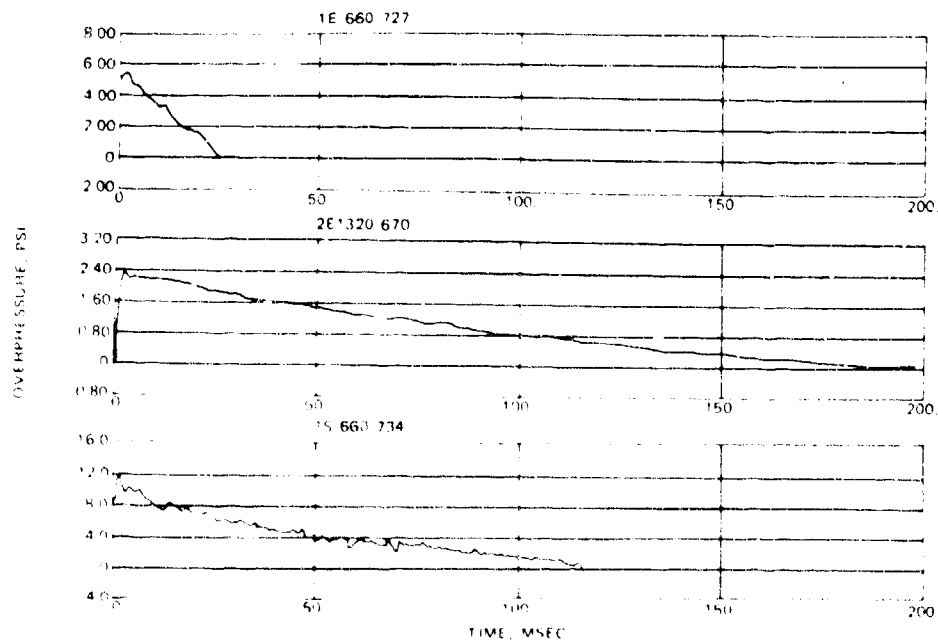
FIGURE 33. Data Plots for BRT Gauges on the East Leg (see Figure 2) at 660 and 1,320 Feet and the Southwest Leg at 660 Feet. The numbers above the plots refer to the distance from the donor. Gauges that registered only the maximum overpressure have been omitted from this series.

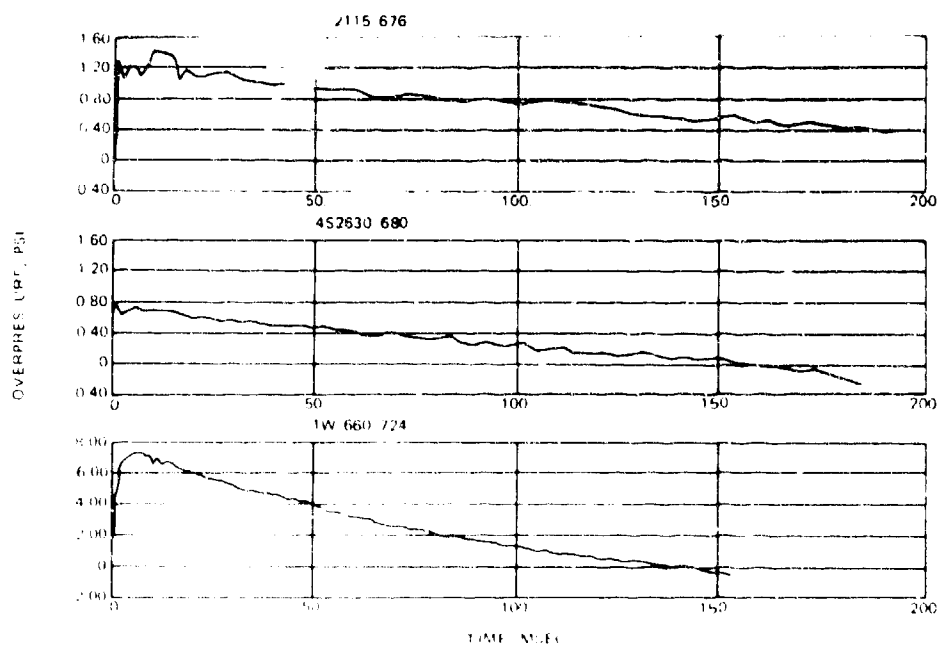
FIGURE 35. Data Plots for BRI Gauges on the Southwest Leg at 2,115 and 2,630 Feet, and the Northwest Leg at 660 Feet.

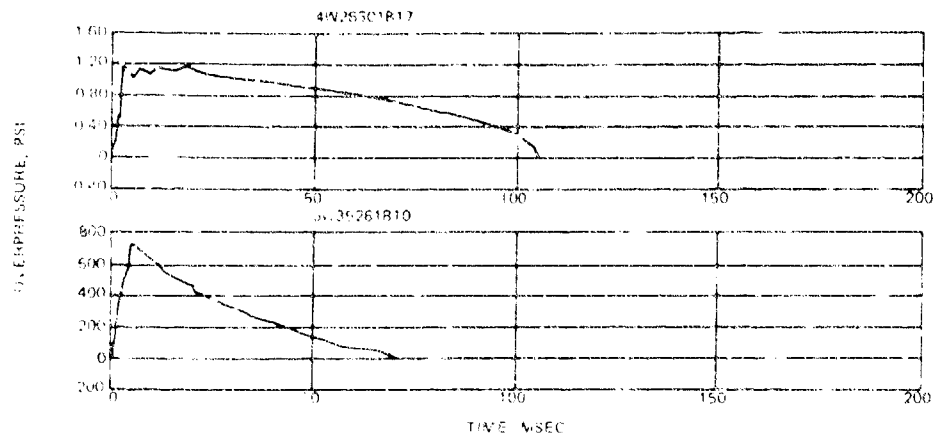
FIGURE 37. Data Plots for GRL Gauges on the Northwest Leg at 2.630 and 3.526 Feet.

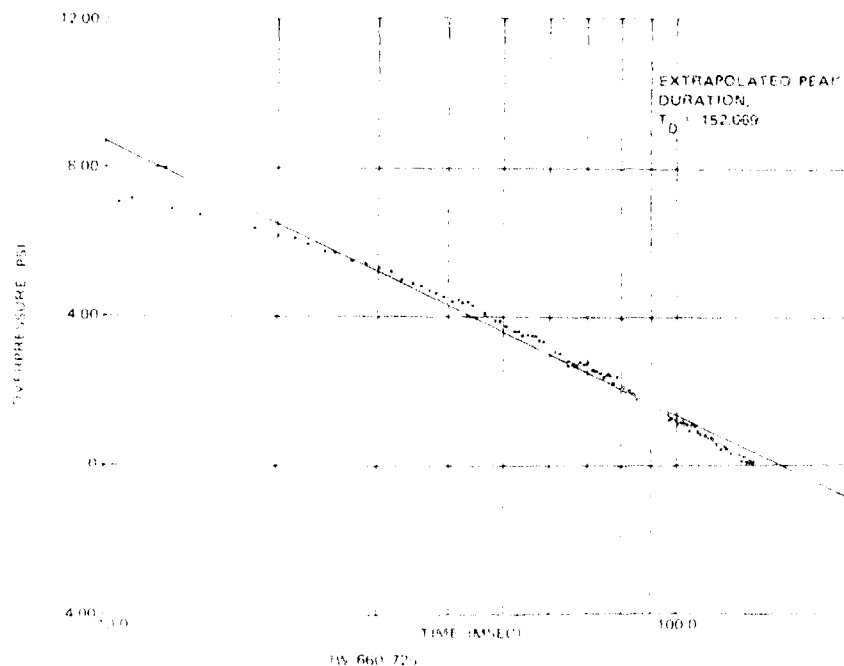
FIGURE 39. Computer Plot of Trailing Edge of Overpressure Curve From BRL Gauge 725.

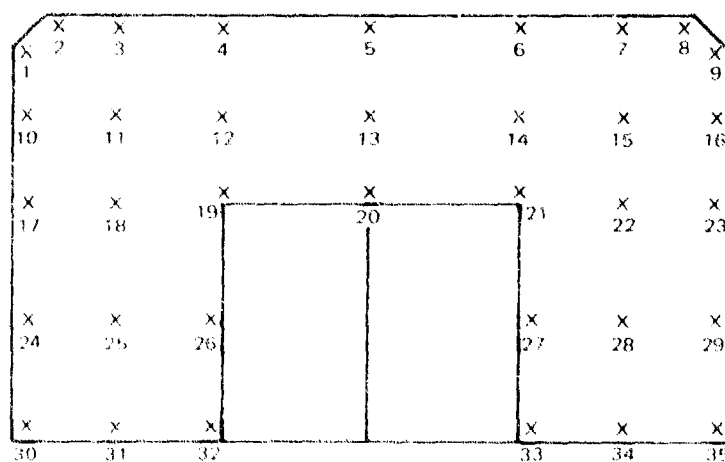
FIGURE 40. Position Key for Headwall Deformation Measurements, Igloos A, C, D, and E.

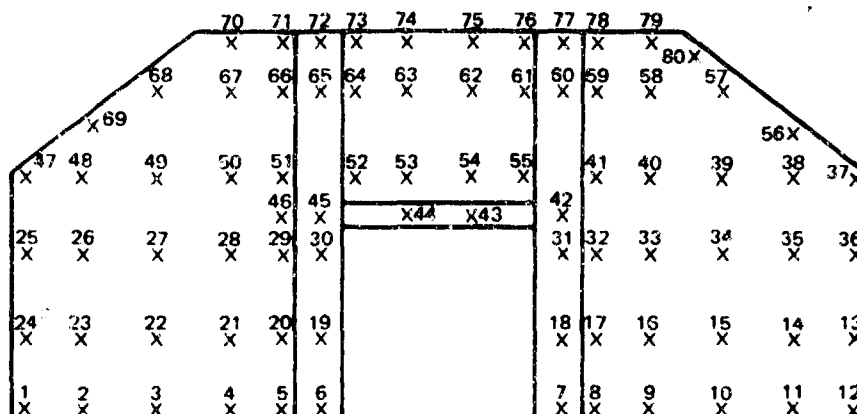
FIGURE 41. Position Key for Headwall Deformation Measurements, Igloo B.

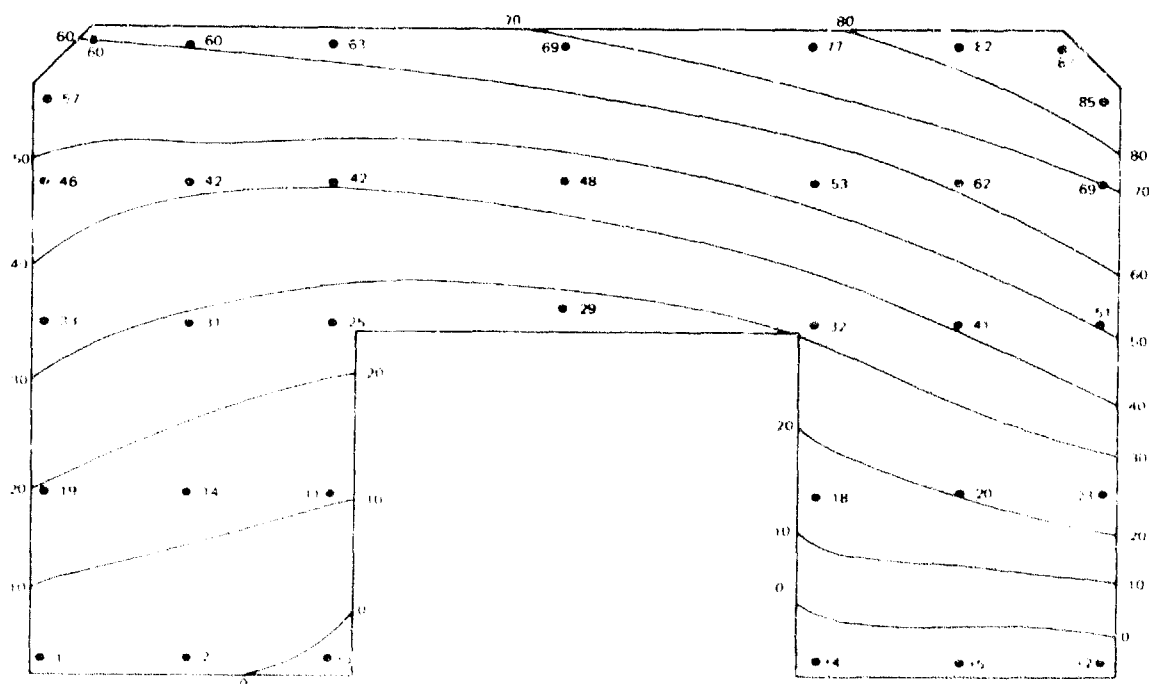
FIGURE 42. Movement of the Headwall of Igloo A. A minus value shows movement outward, toward the donor magazine; a plus value shows movement into the igloo and away from the donor. Units shown are hundredths of feet.

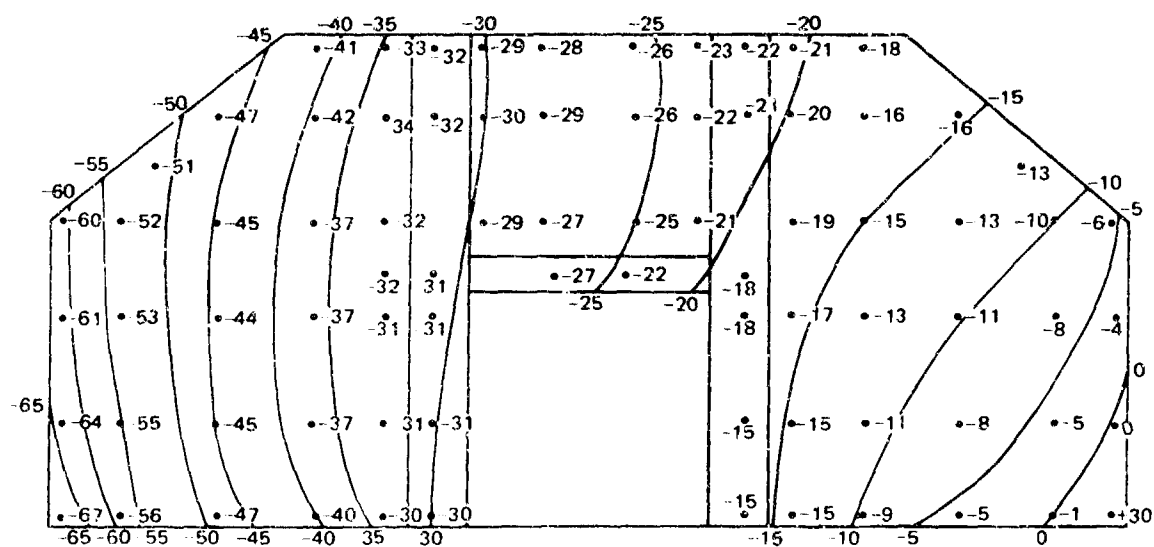
FIGURE 43. Movement of the Headwall of Igloo B. A minus value shows movements toward the donor; the single plus value indicates a movement away from the donor (into the igloo). One point showed no movement. Units shown are hundredths of feet.

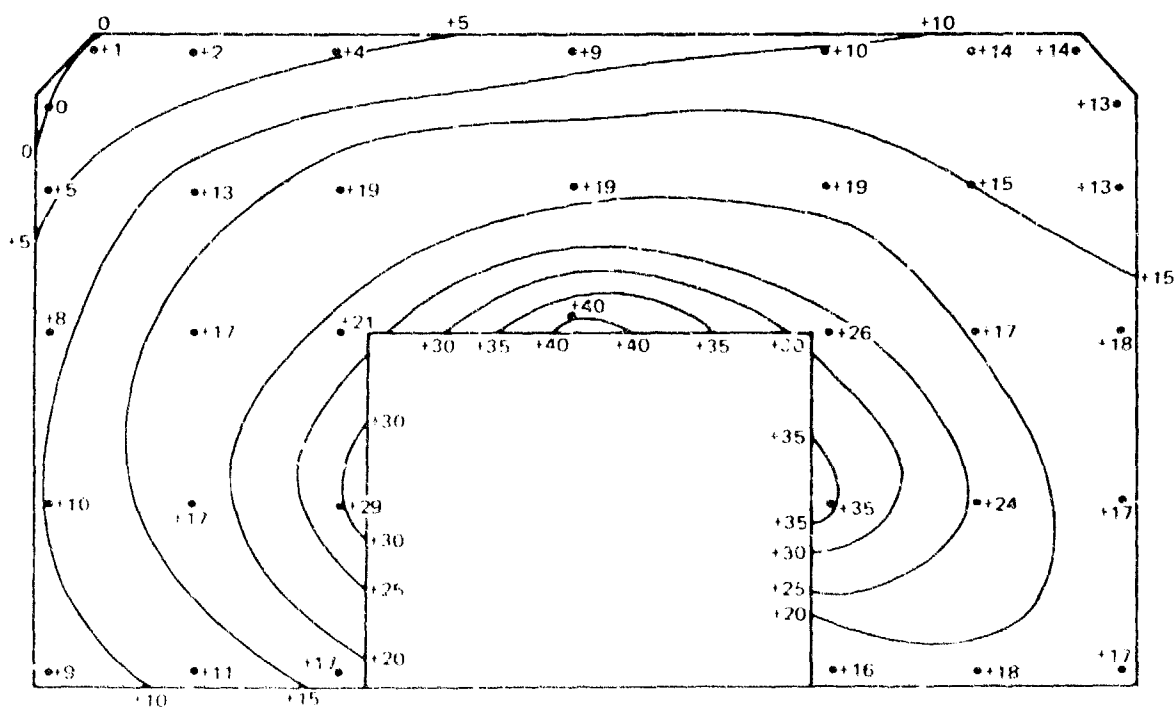
FIGURE 44. Movement of the Headwall of Igloo C. Positive values show movement away from the donor magazine. One point (upper left) showed no movement. Units shown are hundredths of feet.
